ONTARIO MINISTRY OF THE ENVIRONMENT

TOWN OF SMITHS FALLS

GASOLINE CONTAMINATION OF
PRIVATE WELL SUPPLIES

REPORT ON FIELD INVESTIGATIONS

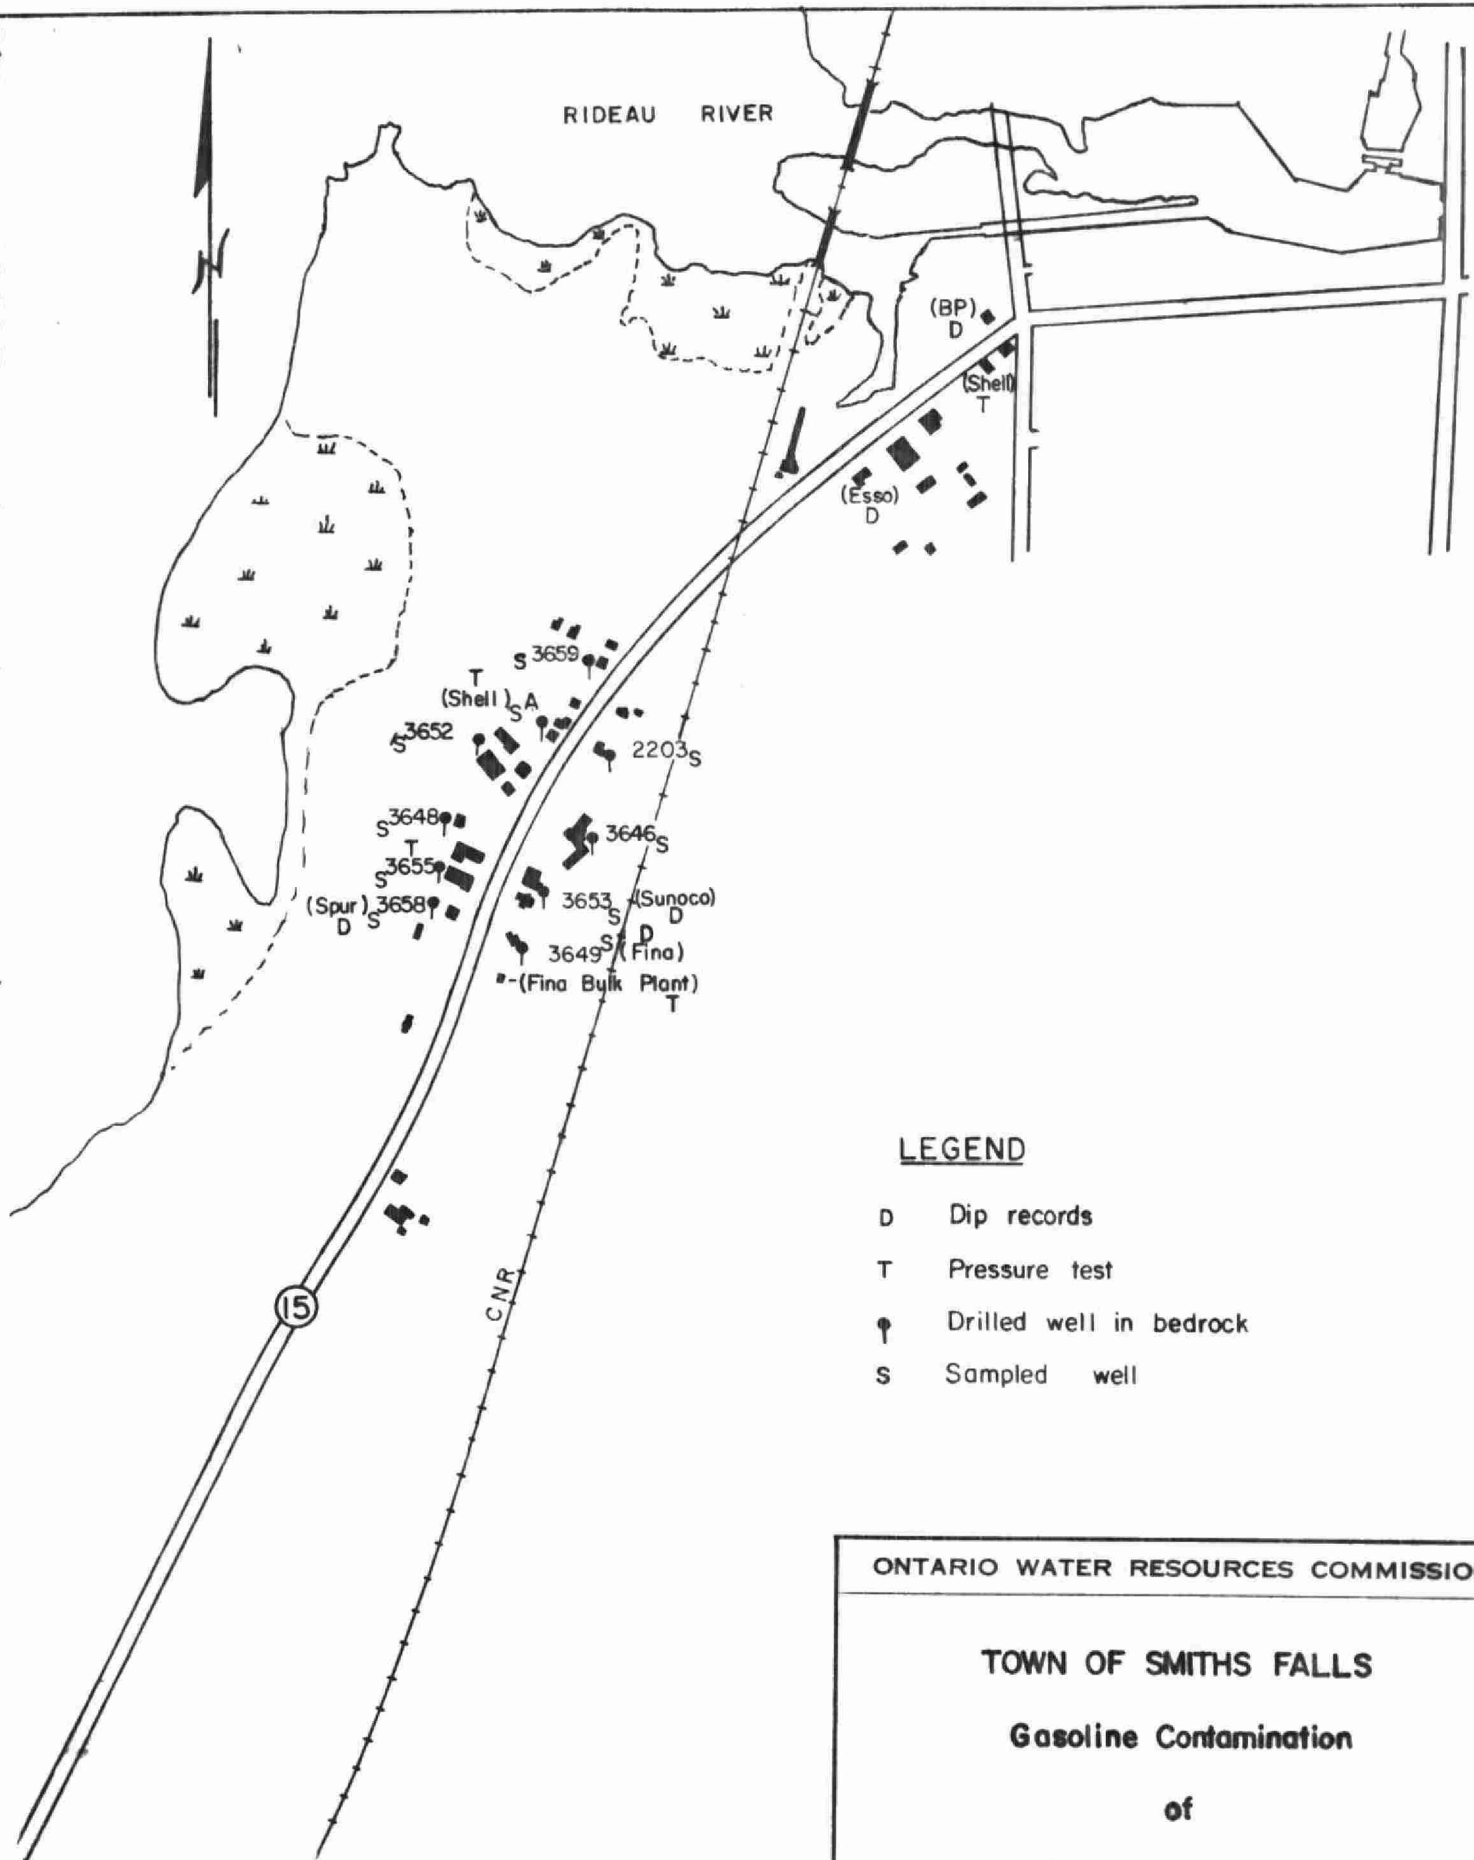
Samples of well waters in the area were collected on November 10, 1971 and analyzed for gasoline and other chemical components. The locations of the sampled wells are shown in Figure 1 and the analyses results are presented in Table 2.

One well adjacent to McCracken Motors, contained water with 25 ppm of gasoline. Another nearby well, at Reynolds Spur Station, contained possible gasoline residues. The Falls Lumber Company well located between these two service stations yields water with gasoline tastes and odours that were quite apparent in the field, however, no gasoline was detected at the laboratory in the water from this well. No other well waters in the area appeared to contain gasoline at the time of the study. This may in part be due to the deepening of many of the wells in the area which were at one time contaminated with a petroleum product. Deepened wells, in which the upper gasoline contaminated zones were cased off, now yield gasoline free waters but taste and odour producing hydrogen sulphide gas, H_2S , is present in the supplies.
